ERECTOR NOTE:

BACK BED WITH SEALANT BEFORE THE WINDOW IS INSTALLED OR CAP SEAL AFTER THE WINDOW IS INSTALLED TO INSURE A WATERTIGHT SEAL.

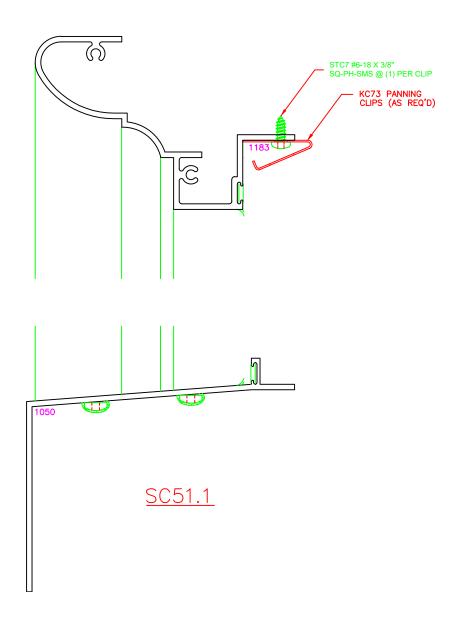
<u>NOTE:</u> THE PANNING OVERLAP ON THE WINDOW IS TOO LARGE FOR SOME WINDOW SERIES	
THE	PANNING OVERLAP ON
THE	WINDOW IS TOO LARGE
FOR	SOME WINDOW SERIES
